NS5410

2004-09 Nissan 350Z

ATTENTION:

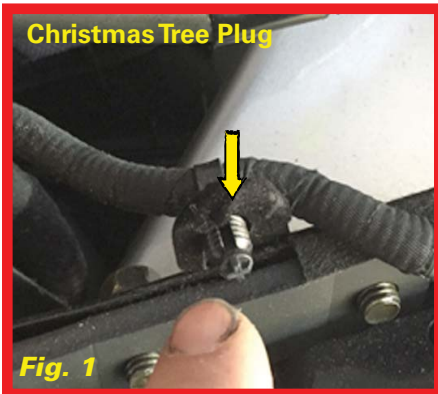
1) The “Christmas Tree” plug holding the defroster lines (fig. 1) is poking holes in the rear section near the bottom quarter panel seam of the top (fig. 2). This plug needs to be removed and replaced with a wire tie.

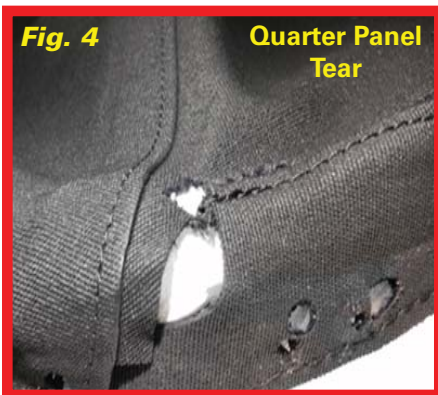
2) Tears occur in the bottom of the quarter panel (fig. 4) behind the door glass when the rear bow is positioned behind the rear bow seam (fig. 5) as the top is being stretched forward to attach to the header during installation.

Be sure to position the rear bow in front of the rear bow seam (fig. 6) before stretching forward. This tear may also occur if the elastic straps used to keep the bows properly positioned during frame operation are not properly installed; (not stretched enough will also cause pinch holes around the rear glass window).

*** IMPORTANT -** (The elastic straps must be stretched using FULL TENSION).
