Madza Glass Strap Installation for MZ8380 Top

Converting the 1989-98 Madza Miata Vinyl Window Top to Glass

(These instructions can also be used with the MZ8340 top)

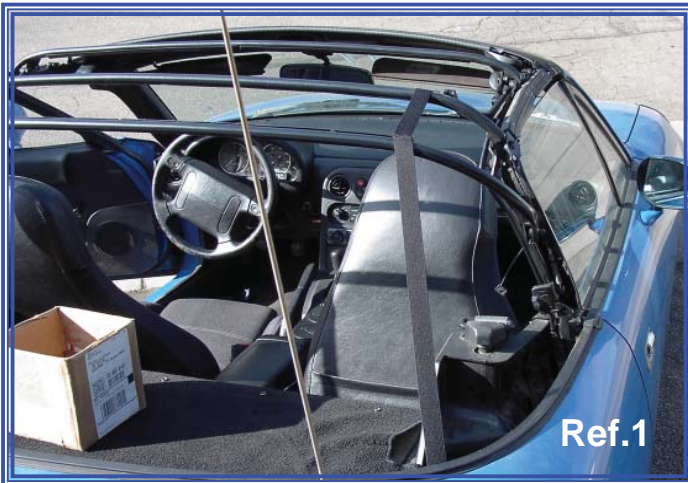
5. Identify the passengers and drivers side webbing by looking at the angle it makes when it is laid out with the folded areas underneath. (Ref.1)
6. Start the strap installation on either side by sliding the middle folded area into the rear bow channel about half way. Secure it with a screw into the hole drilled as described in line (3.). Run the webbing towards the second bow and do the same. Repeat this procedure on the other side. (Ref.2)

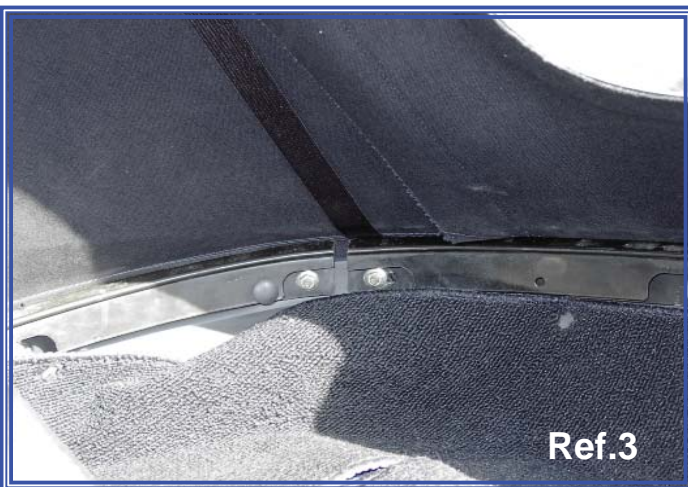
7. Finish the strap installation by bringing the trailing end with the 1" fold, down to the belt line and secure it behind the bracket bolt just to the inside of the gap created by the brackets. (Ref.3).

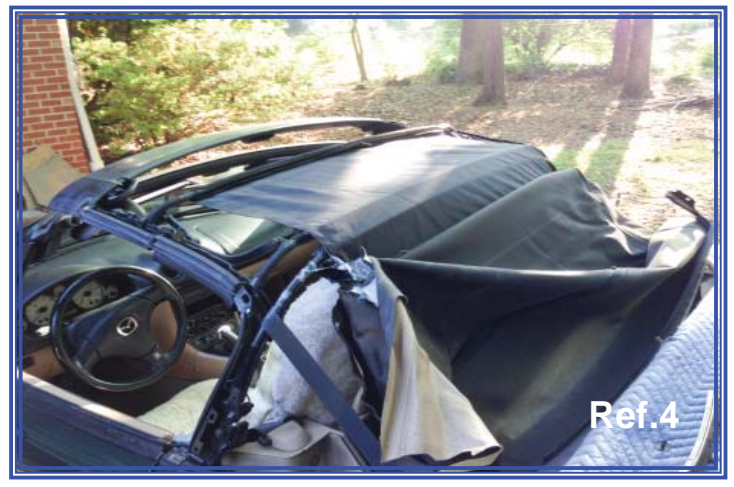
8. The headliner piece (Ref.4) goes over the top of the rear two bows, then underneath the first bow and attaches to the front header. We include 2 bow sleeves with Velcro attached. These sleeves wrap around the rear two bows and fit in between the webbing straps. The sole purpose of these sleeves is to cover the exposed metal bows.

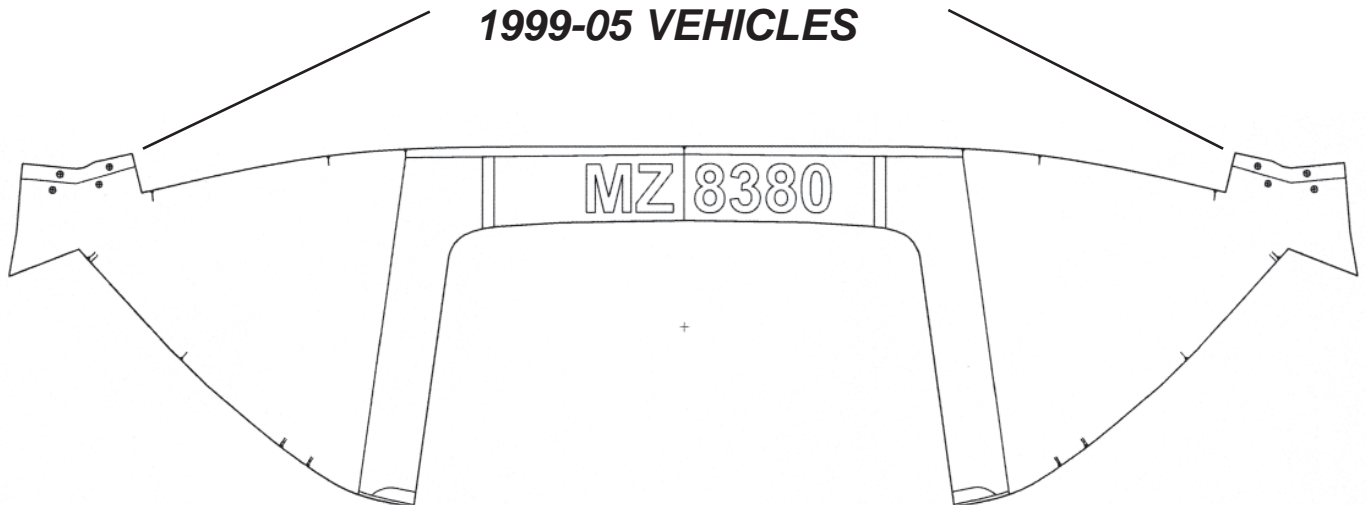
IF YOU ARE INSTALLING THIS MZ8380 TOP ON A 1999-05 CAR YOU MUST TRIM OFF THE QUARTER CORNER AS PER THE DIAGRAM BELOW.

**CUT OFF CORNER AT THIS LINE
ONLY ON
1999-05 VEHICLES**
